# Manhole Inspection Summary

Manhole # S51CC\_026MH

Insp Date: **6/27/08 11:08 AM**

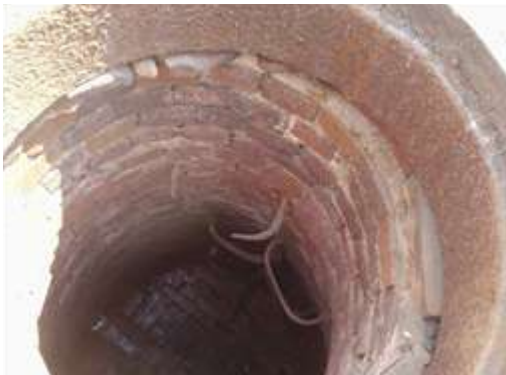
Defect 2

Count: **5** Missing: **2** ☒ **Corroded**

corroded steps

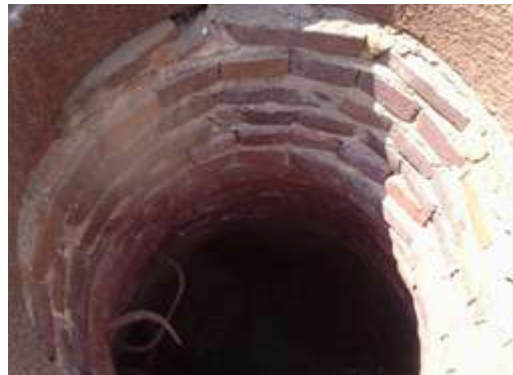
Defect 1

Condition: ☐ Sound ☐ Cracked ☐ Root Intrusion ☒ **Loose Brick** ☐ Deteriorated

Infiltration: ☐ None ☐ Joint ☐ Cracks ☒ **Mortar** ☐ Roots ☐ Wall

loose bricks

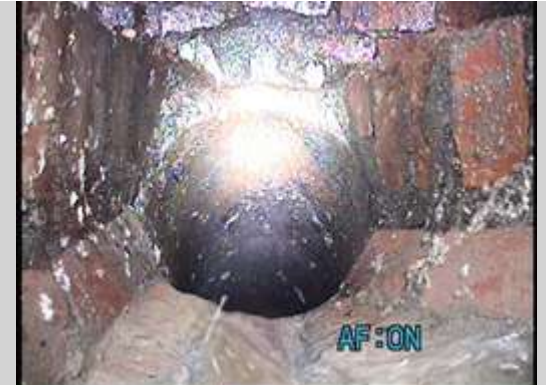
12 O'Clock Outflow

Pipe Height: **8.4** (in.) Rod and Bar (Angled)  
Pipe Material: **Clay** ☐ Pipe Lined  
Invert Depth: **10.80** (ft.) Flow Characteristics: **Fast**  
Deposits: ☒ None ☐ Mud ☐ Sludge ☐ Debris ☐ Grease  
Silt Depth: (in.) Deposits Extent:  
Infiltration: **None** Pipe Seal Cond: **Sound**

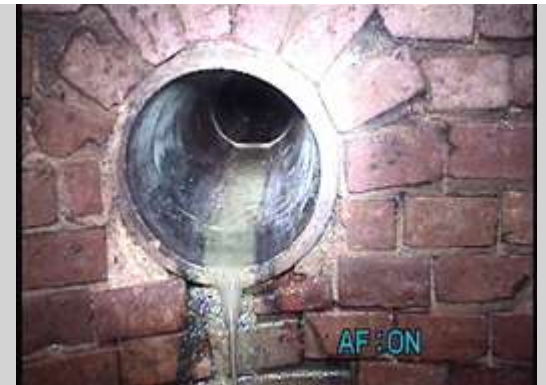
3 O'Clock Inflow

Pipe Height: **8.4** (in.) Rod and Bar (Angled)  
Pipe Material: **Clay** ☐ Pipe Lined  
Invert Depth: **8.55** (ft.) Flow Characteristics: **Fast**  
Deposits: ☒ None ☐ Mud ☐ Sludge ☐ Debris ☐ Grease  
Silt Depth: (in.) Deposits Extent:  
Infiltration: **None** Pipe Seal Cond: **Sound**

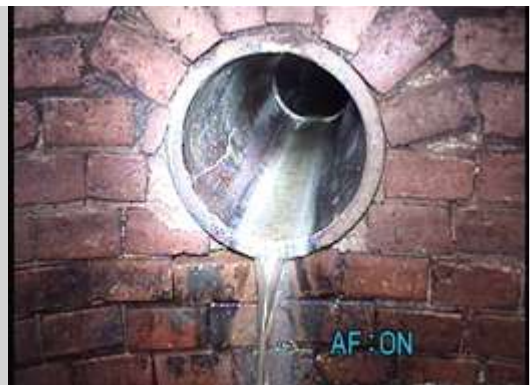
6 O'Clock Inflow

Pipe Height: **8.4** (in.) Rod and Bar (Angled)

Infiltration: **None** Pipe Seal Cond: **Sound**
